CORE-LOC BREAKWATER ARMOUR RESEARCH

Breakwater Survey at Port St Francis

FINAL REPORT

November 1998

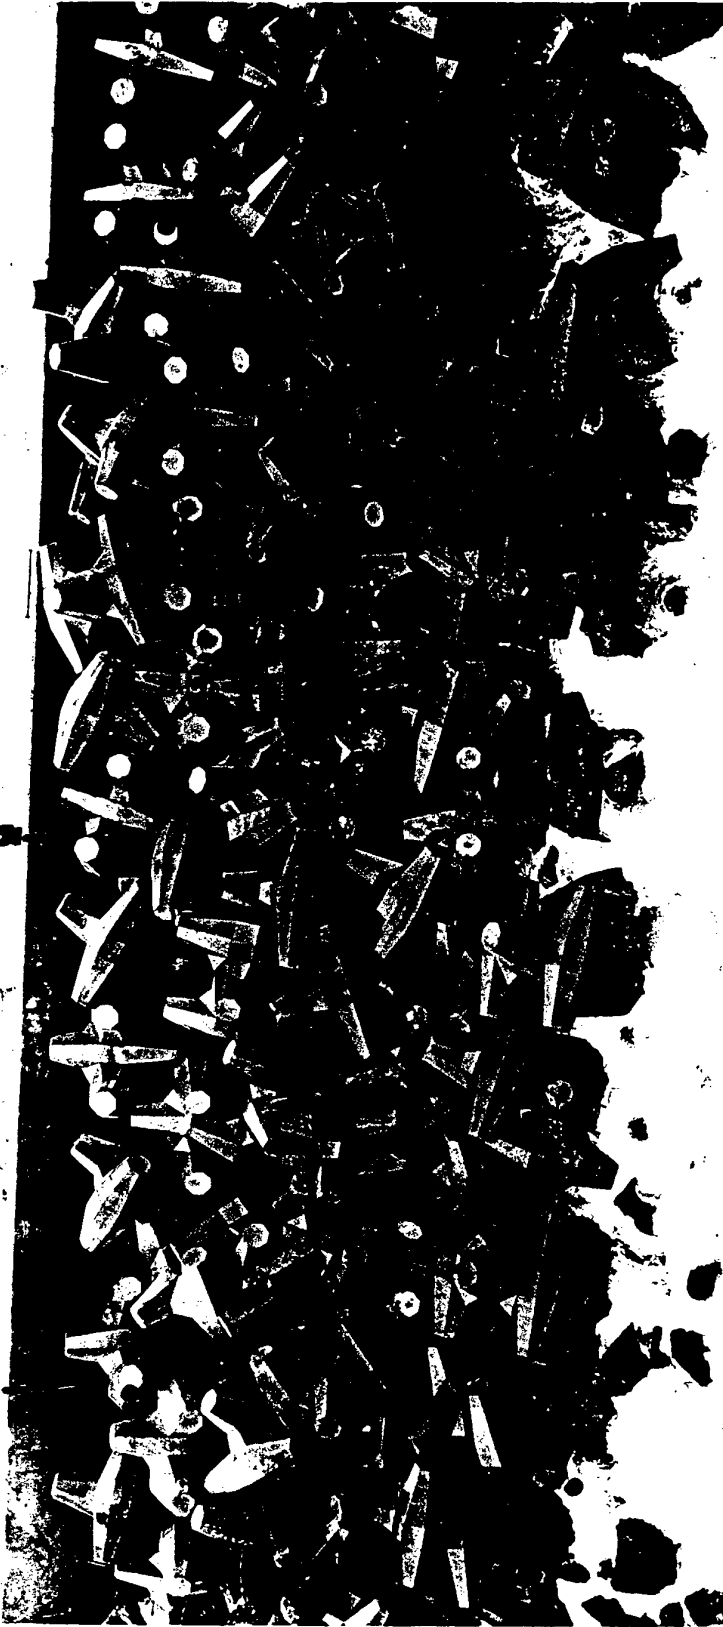
BASELINE PHOTOGRAPHIC SURVEY OCTOBER 1997
 STATION 3

Move (■) : 0 Broken (▲) : 0 Lost (●) : 0
 N = New, P = Pieces, A = <0,5m, B = 0,5m to 1,5m, C = >1,5m

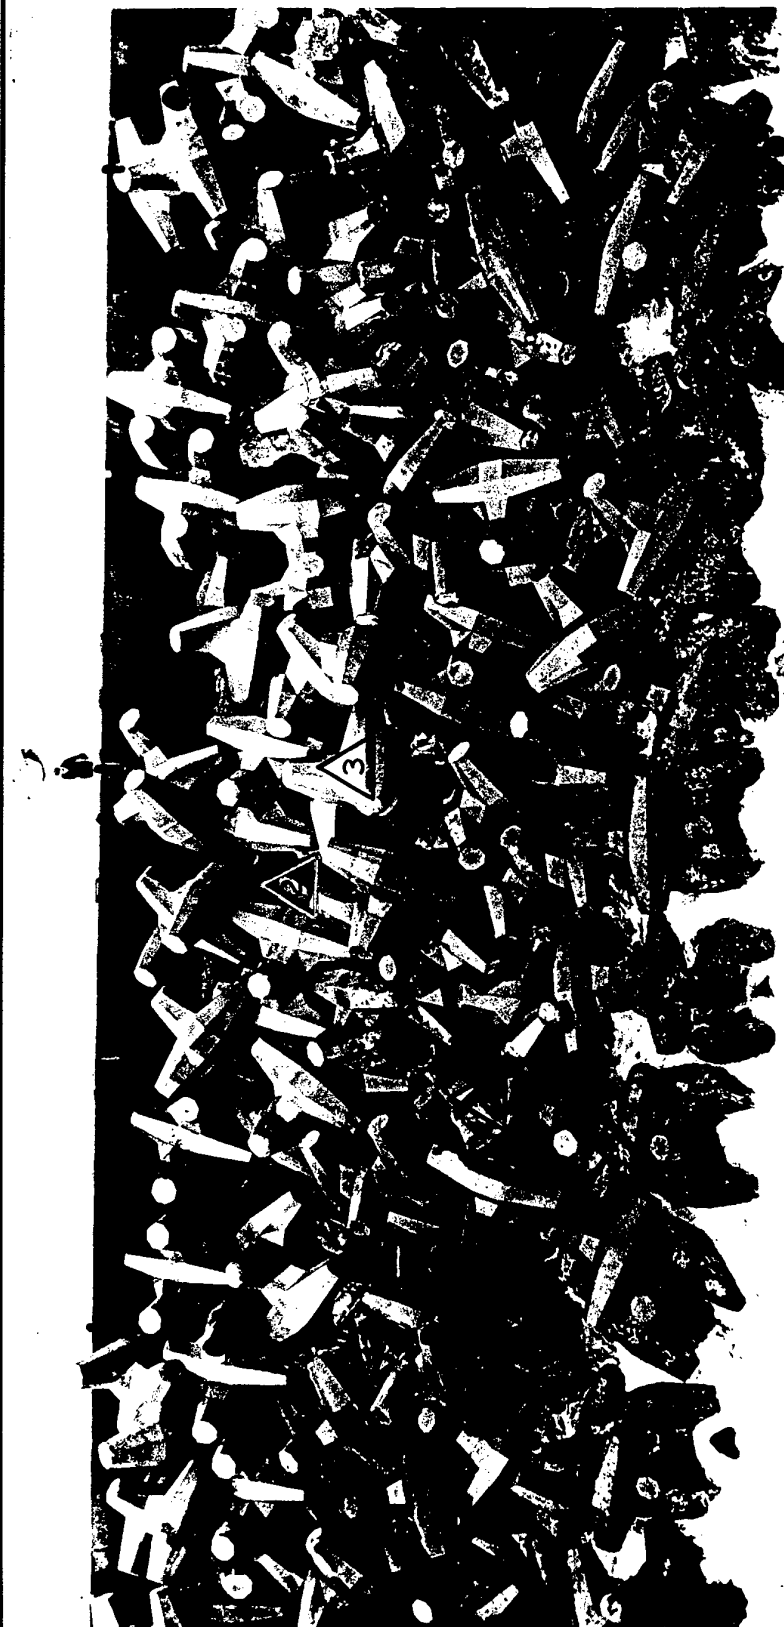
CSIR Your Technology Partner	PORT ST FRANCIS	BASELINE PHOTOGRAPHIC SURVEY OCTOBER 1997 STATION 4	FIGURE 14
---	-----------------	--	----------------------------

Move (■) : 0 Broken (▲) : 3 Lost (●) : 0
N = New, P = Pieces, A = <0,5m, B = 0,5m to 1,5m, C = >1,5m

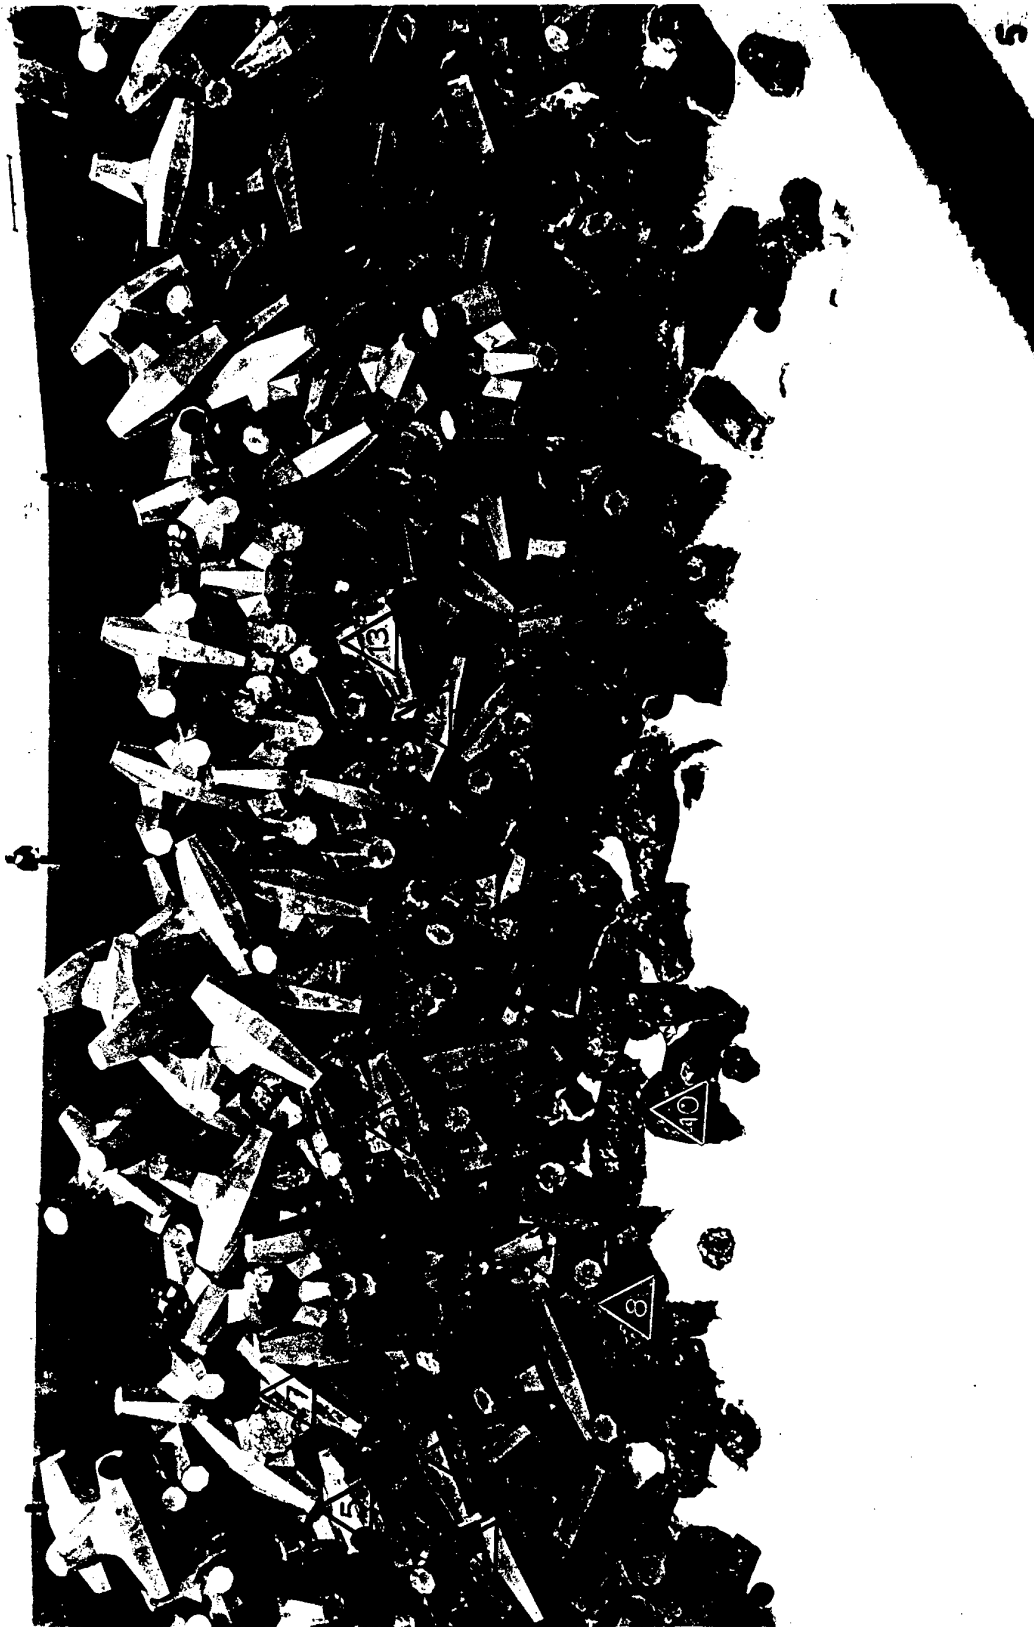
BASELINE PHOTOGRAPHIC SURVEY OCTOBER 1997
 STATION 5

Move (■) : 0 Broken (▲) : 10 Lost (●) : 0
 N = New, P = Pieces, A = <0,5m, B = 0,5m to 1,5m, C = >1,5m

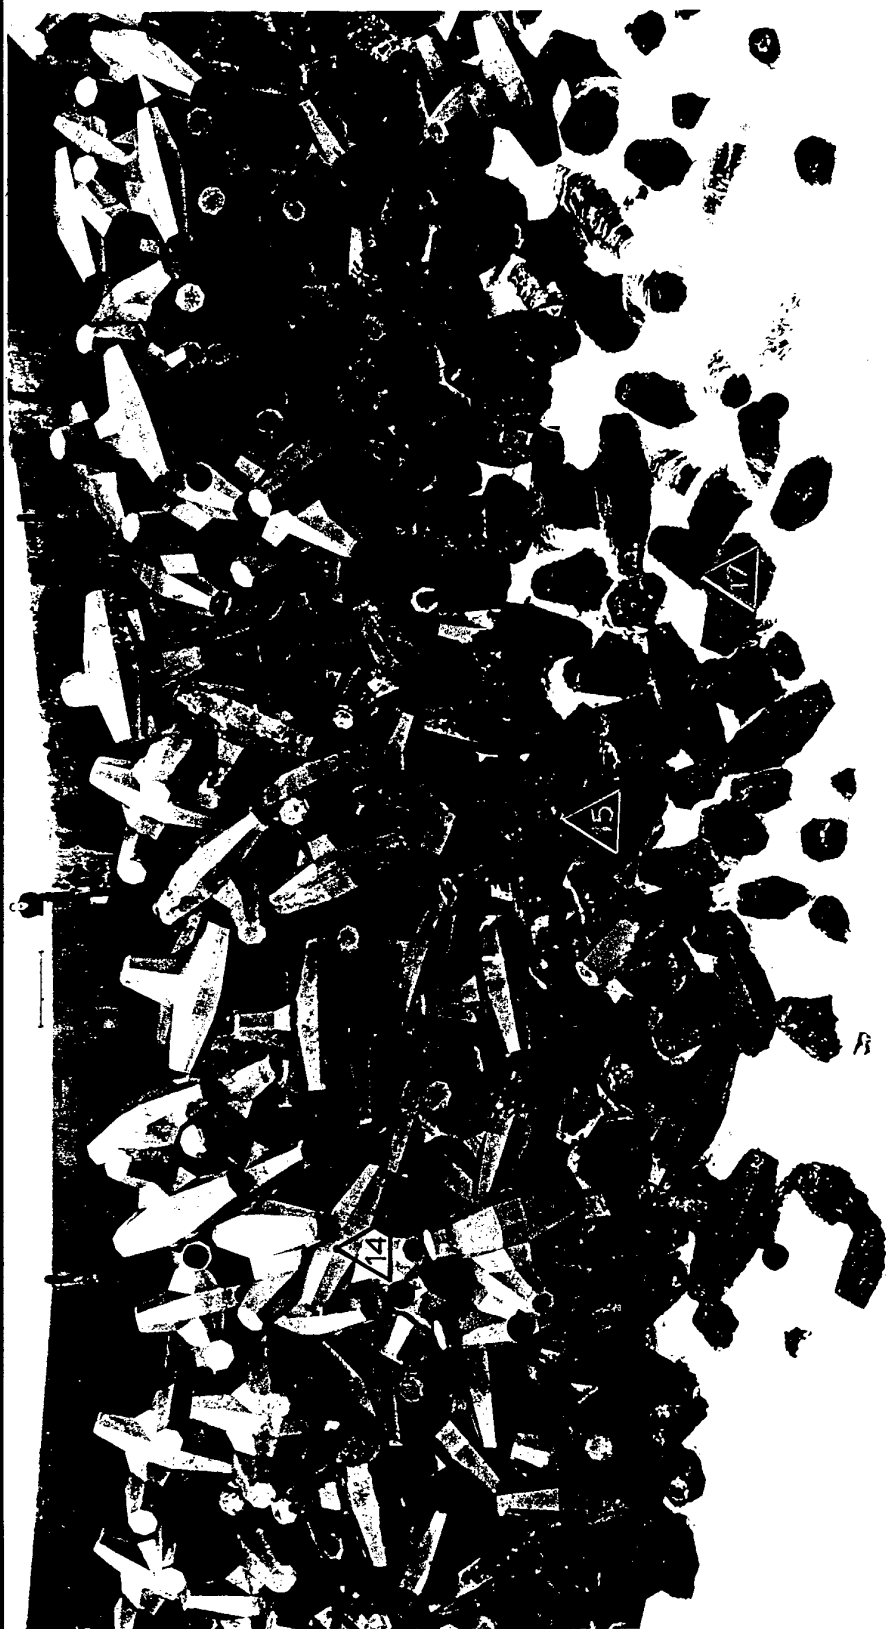
**BASELINE PHOTOGRAPHIC SURVEY OCTOBER 1997
 STATION 6**

Move (■) : 0 Broken (▲) : 4 Lost (●) : 0
 N = New, P = Pieces, A = <0,5m, B = 0,5m to 1,5m, C = >1,5m

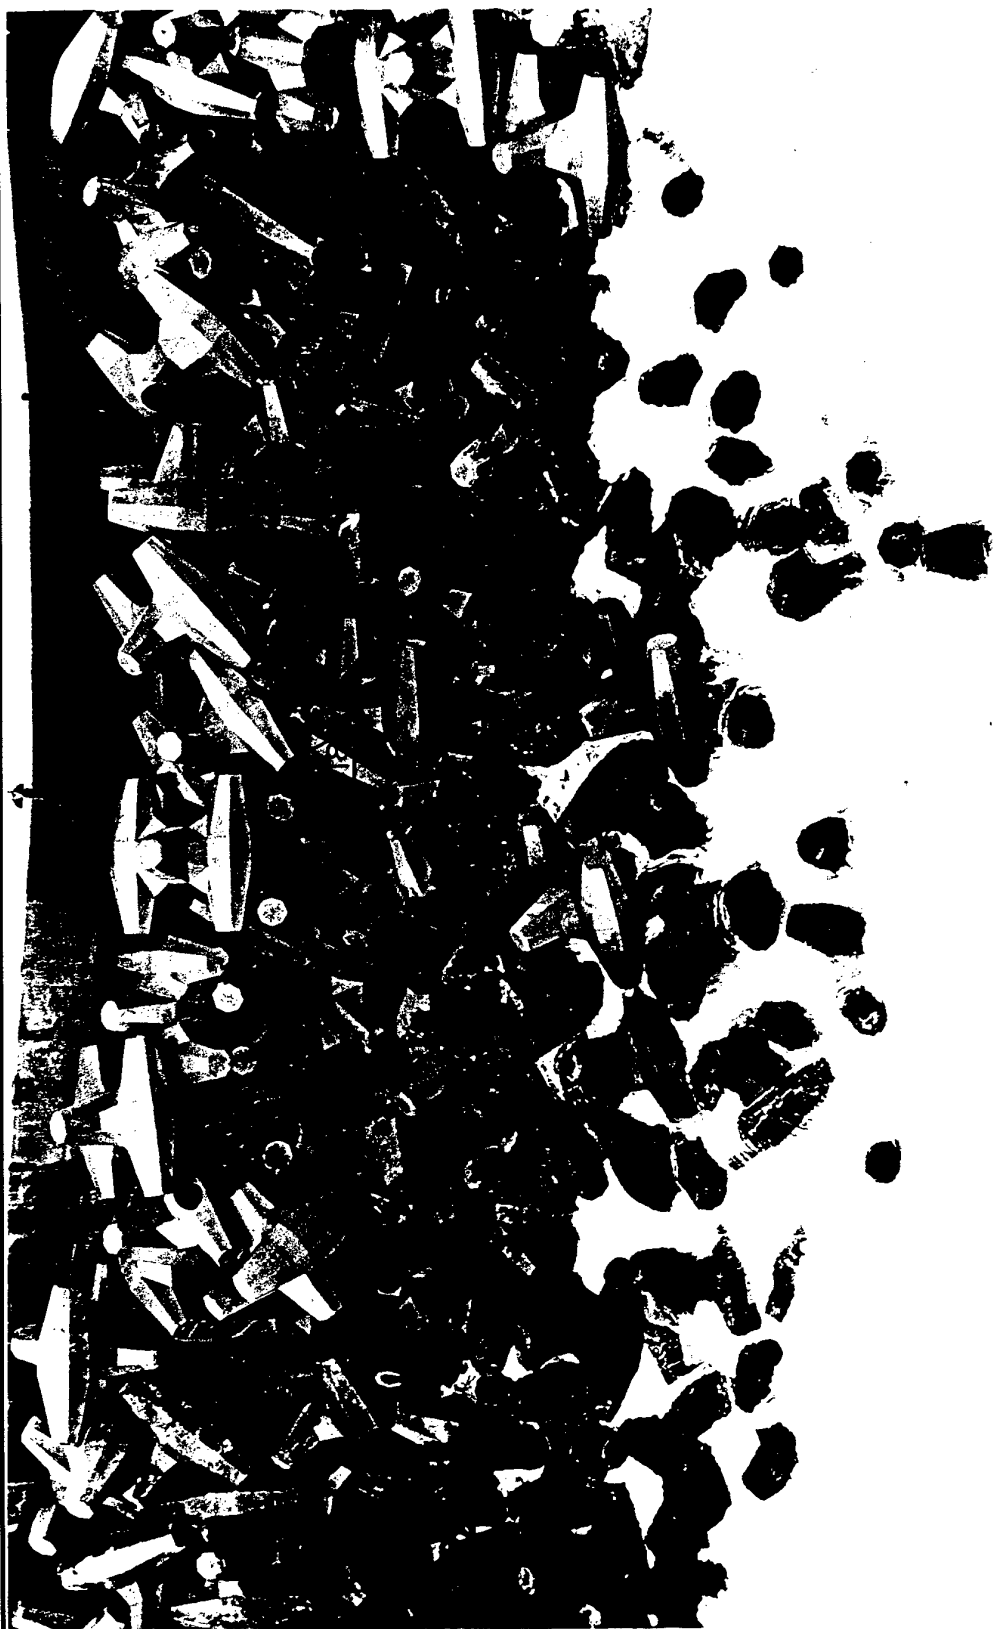
BASELINE PHOTOGRAPHIC SURVEY OCTOBER 1997
 STATION 7

Move (■) : 0 Broken (▲) : 1 Lost (●) : 0
 N = New, P = Pieces, A = <0,5m, B = 0,5m to 1,5m, C = >1,5m

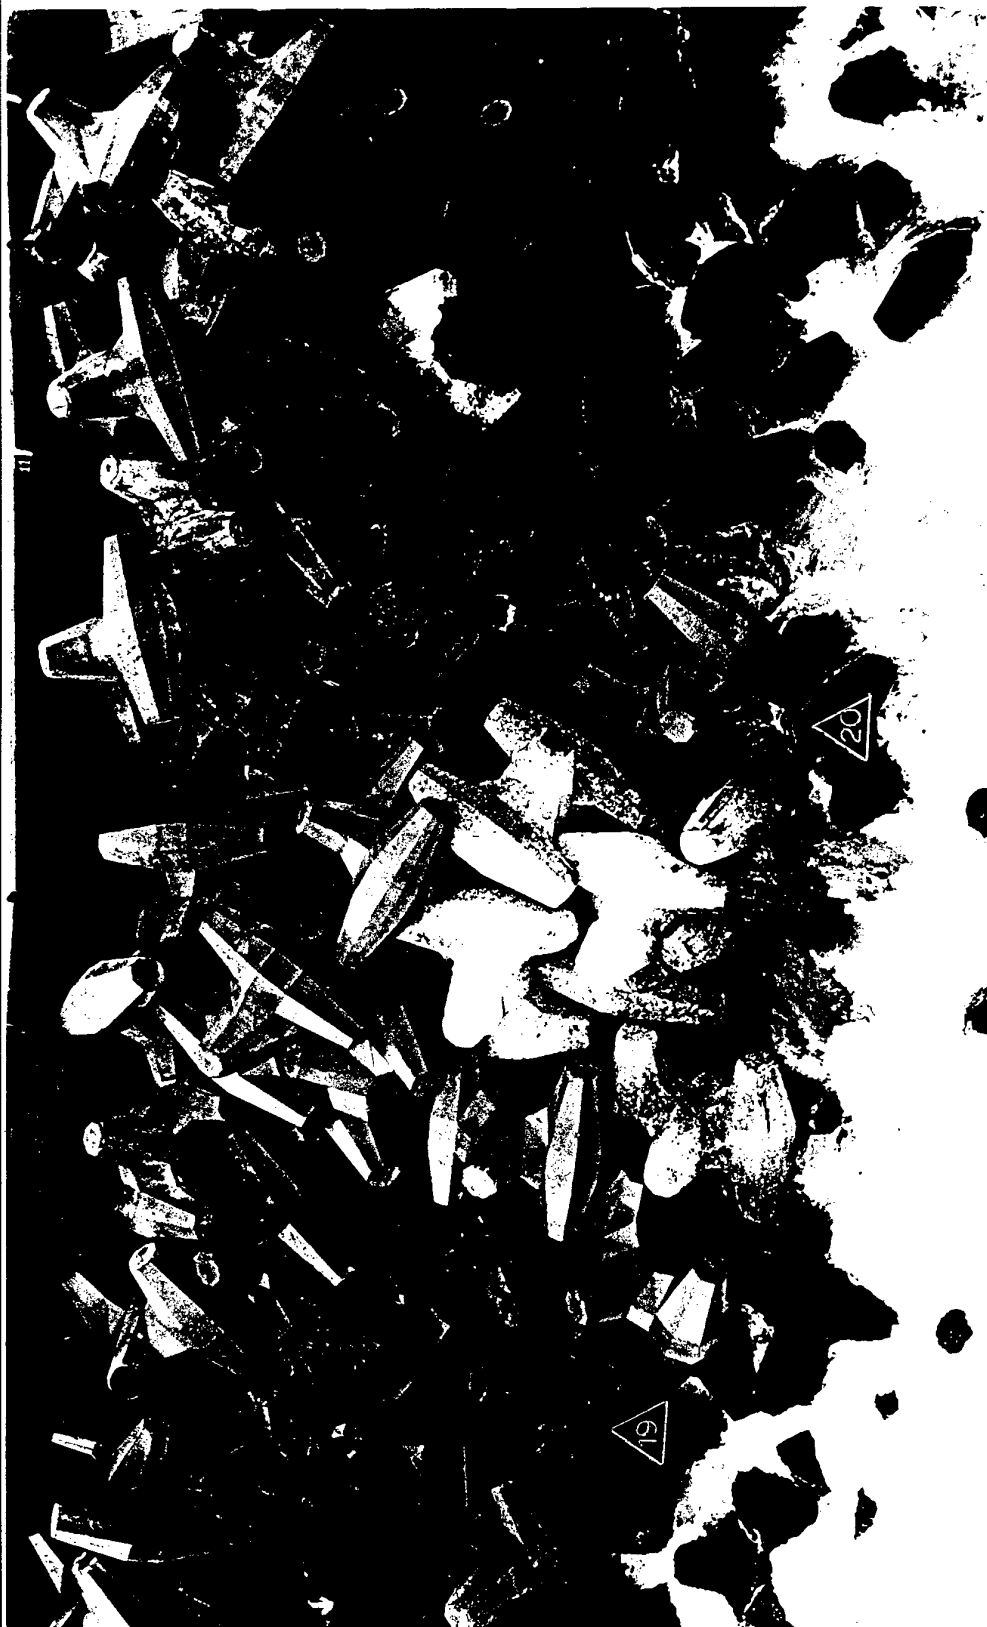
BASELINE PHOTOGRAPHIC SURVEY OCTOBER 1997
STATION 8

Move (■) : 0 Broken (▲) : 3 Lost (●) : 0
 N = New, P = Pieces, A = <0,5m, B = 0,5m to 1,5m, C = >1,5m

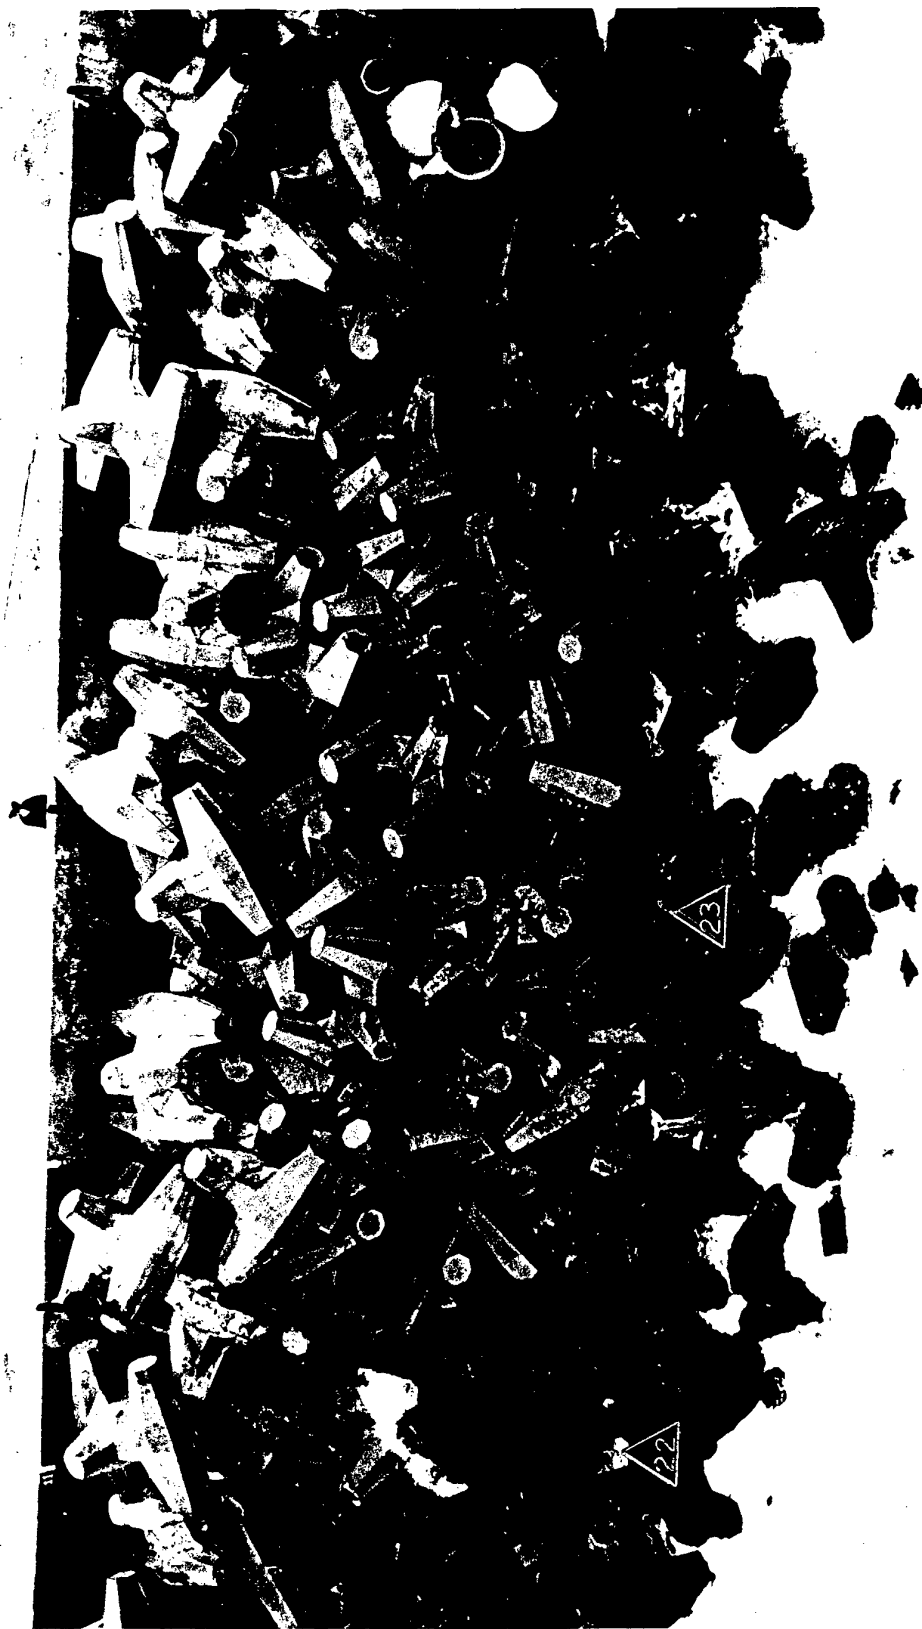
BASELINE PHOTOGRAPHIC SURVEY OCTOBER 1997
 STATION 9

Move (■) : 0 Broken (▲) : 2 Lost (●) : 0
 N = New, P = Pieces, A = <0,5m, B = 0,5m to 1,5m, C = >1,5m

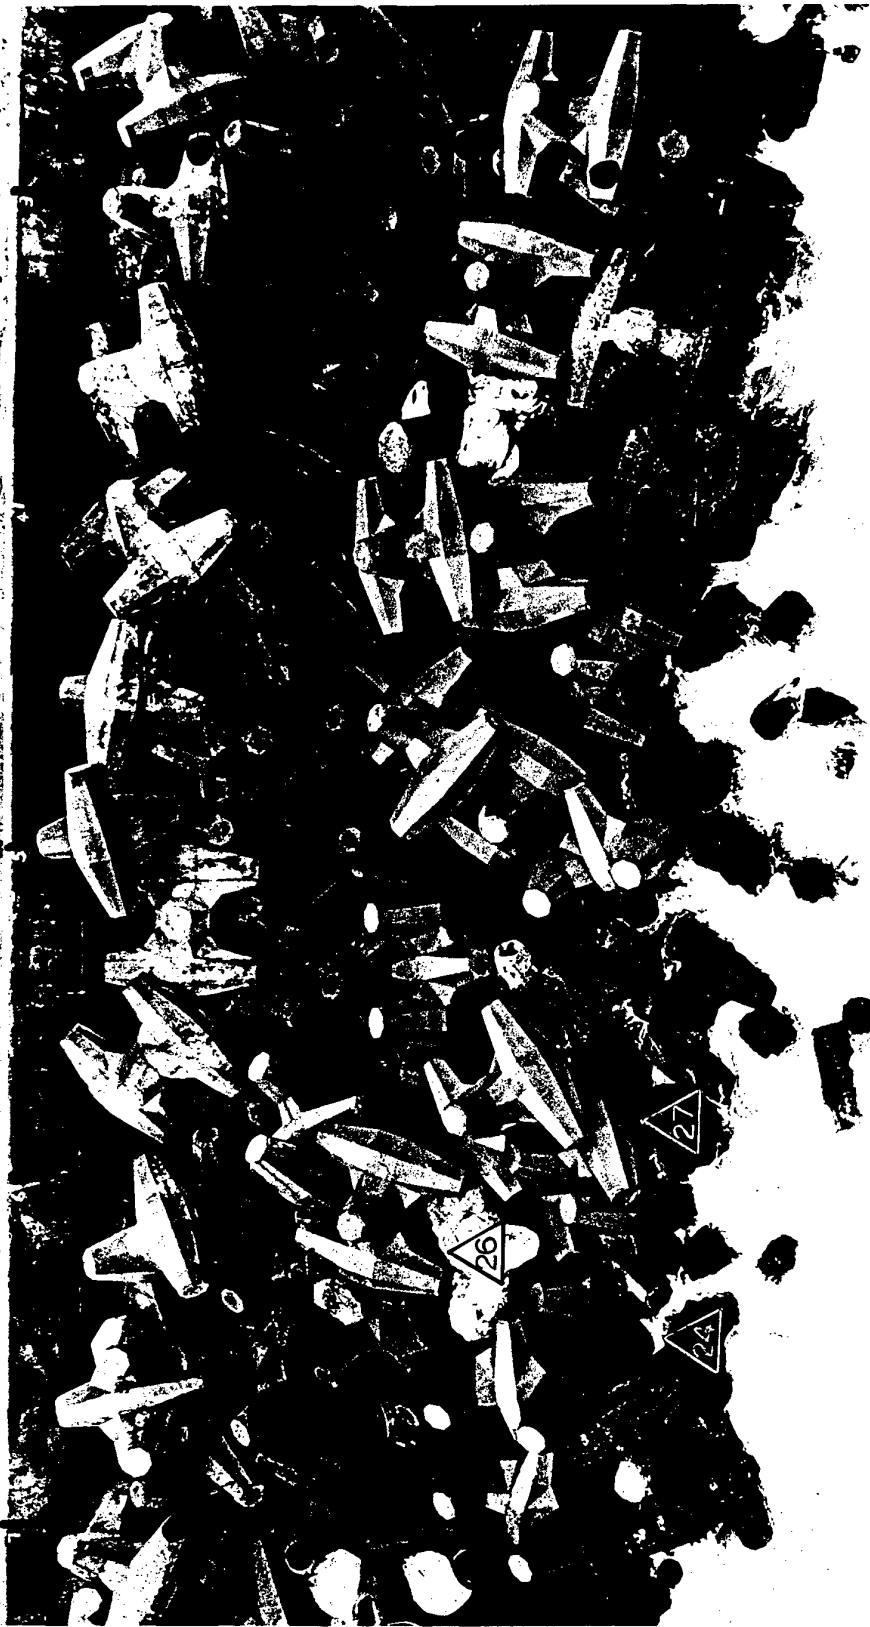
20

Move (■) : 0 Broken (▲) : 6 Lost (●) : 0

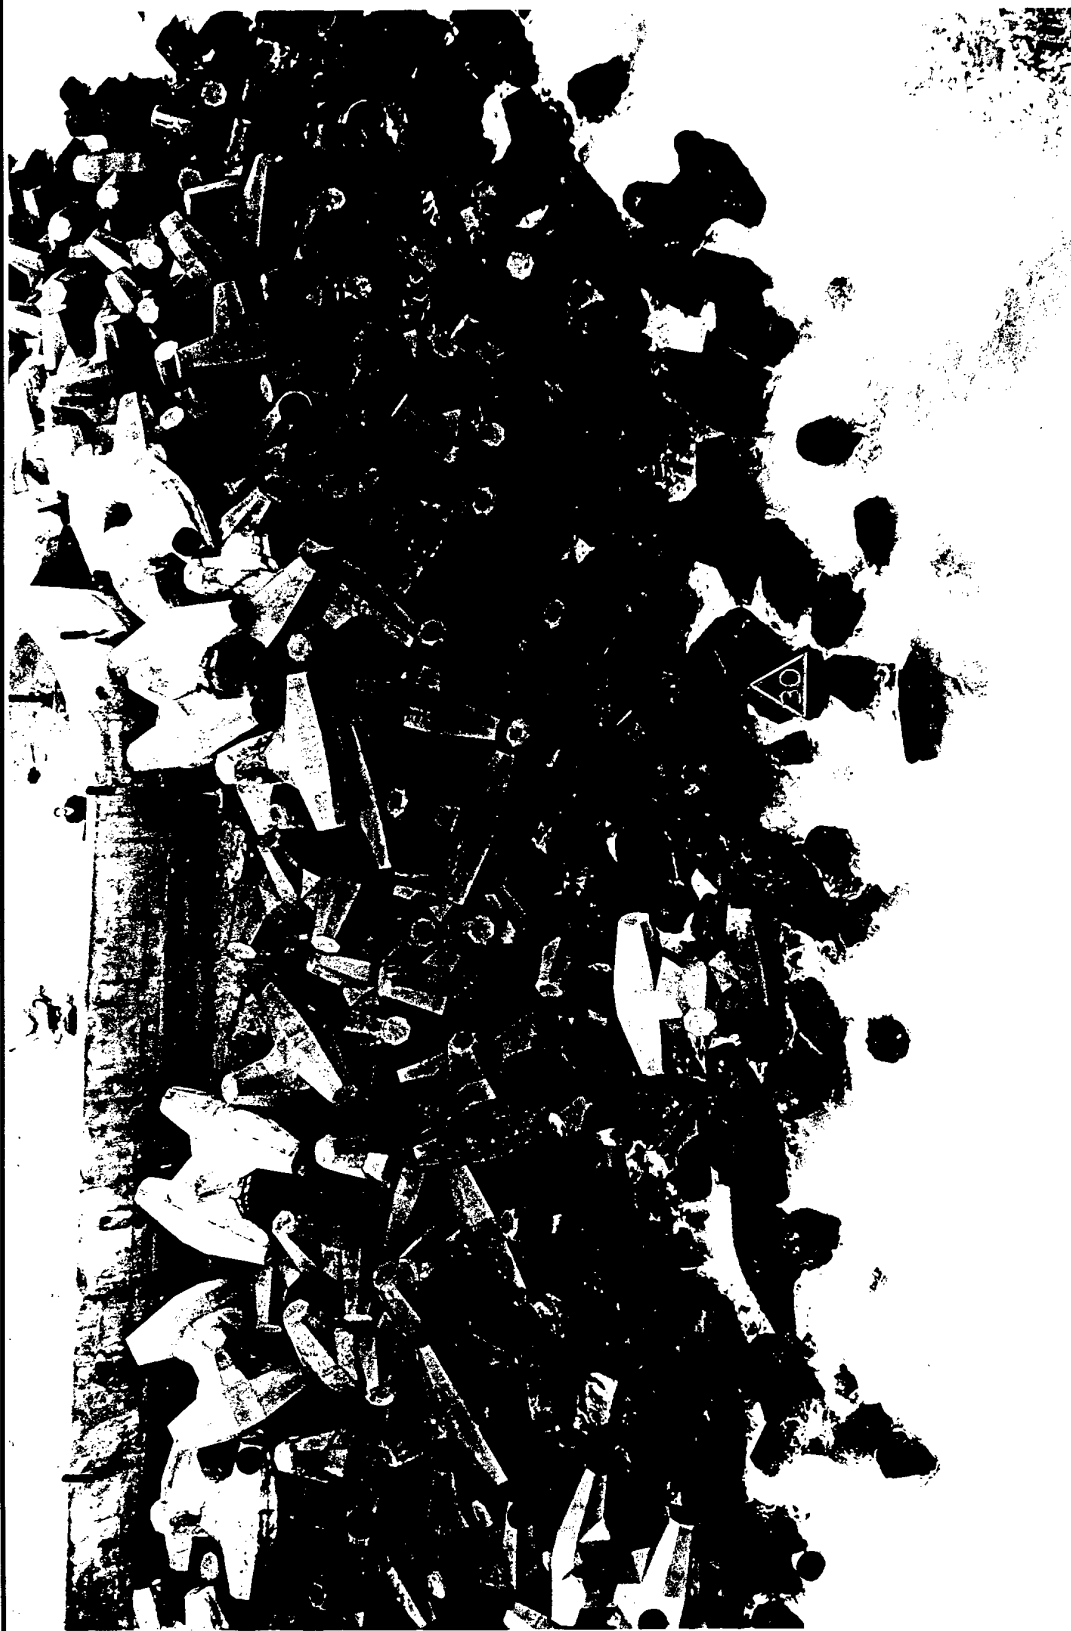
21

Move (■) : 0 Broken (▲) : 1 Lost (●) : 0

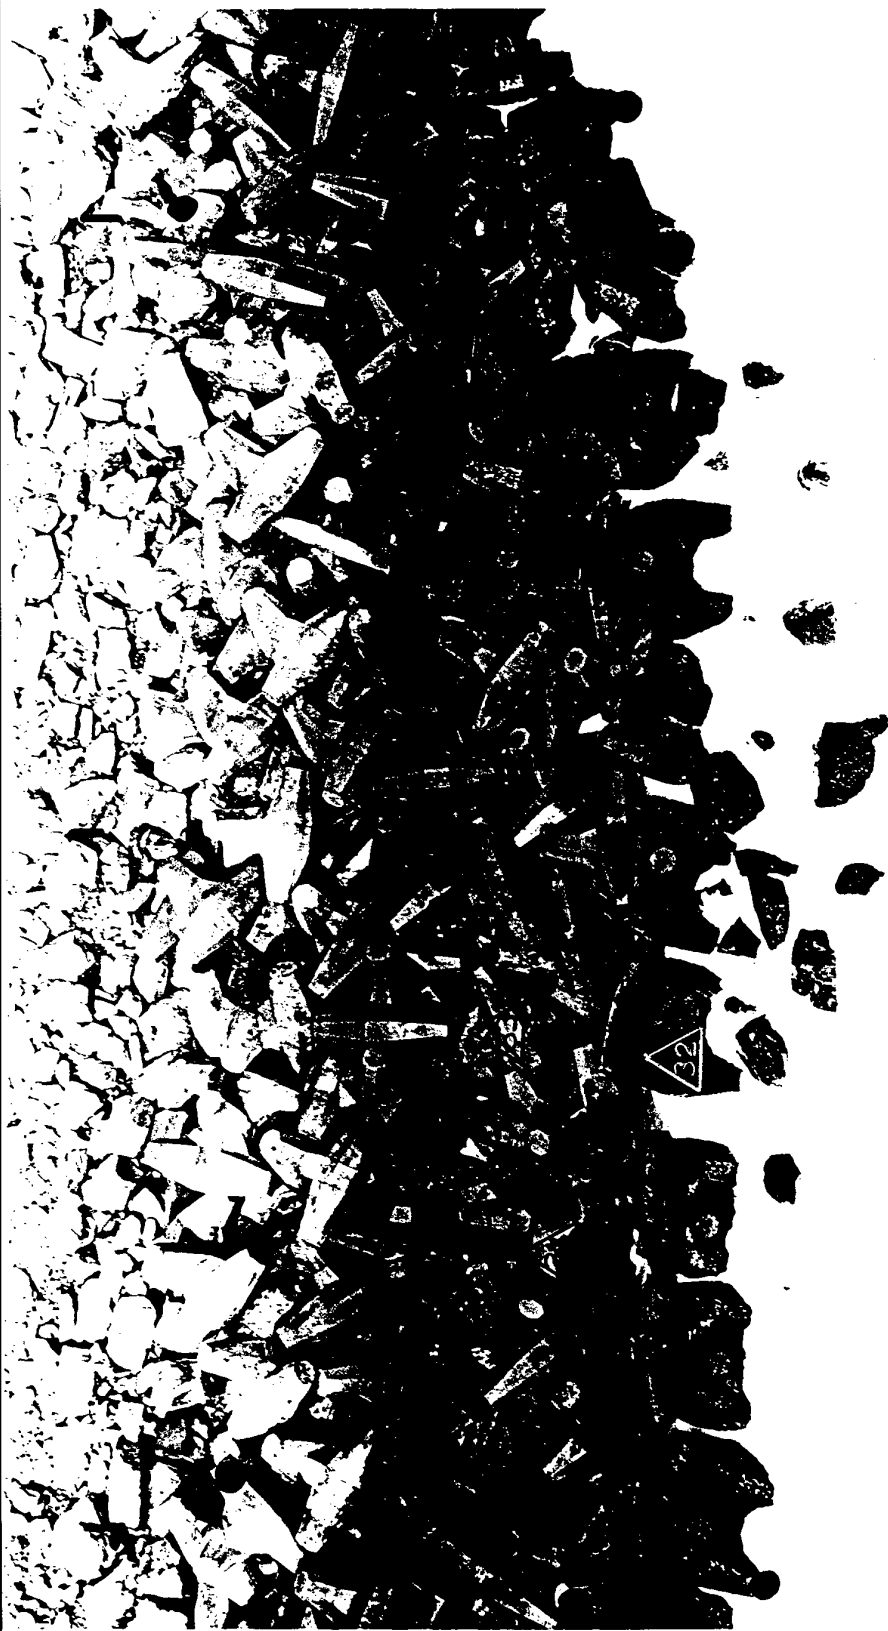
25

Move (■) : 0 Broken (▲) : 4 Lost (●) : 0
 N = New, P = Pieces, A = <0,5m, B = 0,5m to 1,5m, C = >1,5m
